Manhole Inspection Summary

Manhole # S51M__043MH

Insp Date: **4/10/08 1:52 PM**

Location Address: **1021 Dillon-ODonnell**

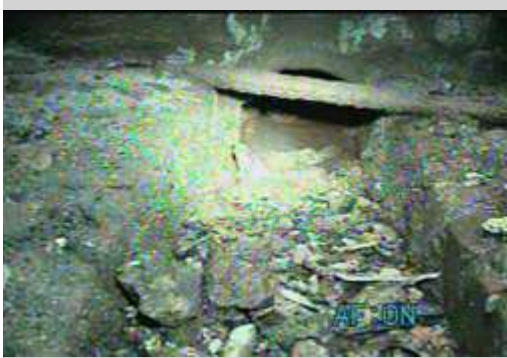
Defect 2

Condition: ☐ Sound ☐ Cracked ☐ Root Intrusion ☐ Deteriorated ☐ Leaks ☒ **Debris**

channel debris

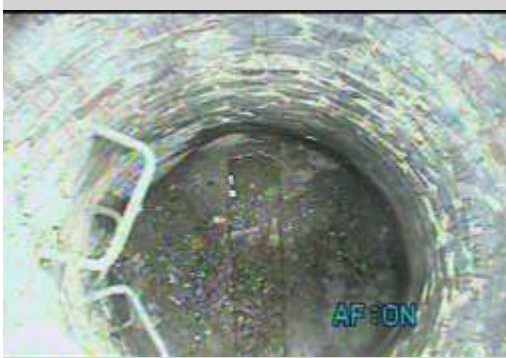
Defect 5

Condition: ☐ Sound ☐ Cracked ☐ Root Intrusion ☐ Deteriorated ☐ Leaks ☒ **Debris**

Bench Debris

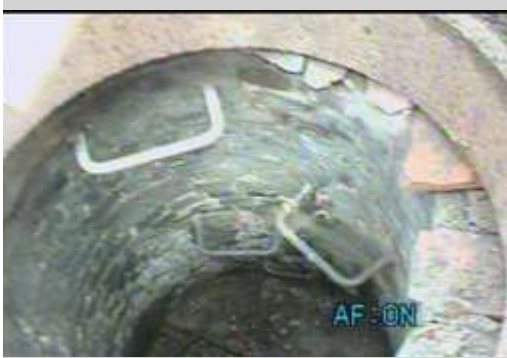
Defect 3

Steps Count: **5** Missing: **0** ☒ **Corroded**

corroded stairs

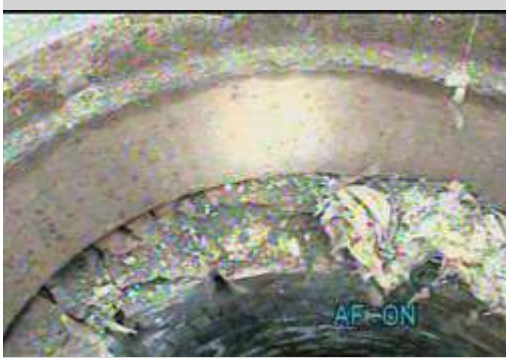
Defect 4

Frame Offset: **4** (in.) Condition: ☒ Sound ☐ Cracked ☐ Leaks

off set frame

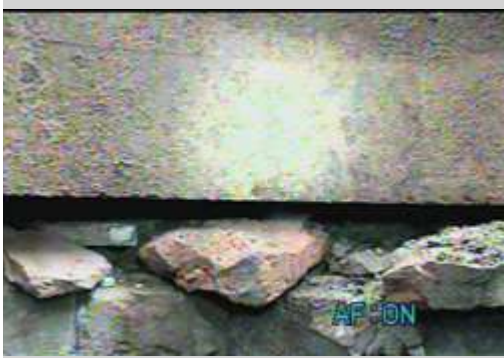
Defect 1

Condition: ☐ Sound ☐ Cracked ☐ Root Intrusion ☒ **Loose Brick** ☐ Deteriorated

loose bricks in chimney, frame adjustment

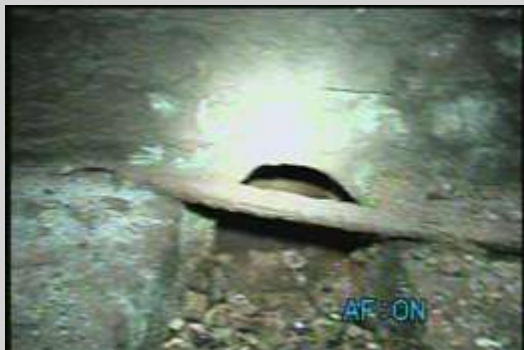
12 O'Clock Outflow

8 in. Circular Gravity Sewer
Pipe Out @ 12 O'Clock

Deposits: ☐ None ☐ Mud ☐ Sludge ☒ **Debris** ☐ Grease
